# 2016-2017 Central Italy Earthquake: Seismic Assessment of "Pietro Capuzi" School in Visso (Marche)

# †\*Chiara Ferrero¹, Paulo B. Lourenço², and Chiara Calderini¹

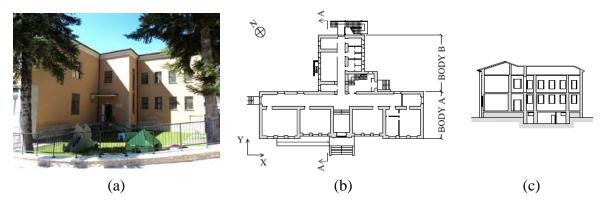
Figure 1 – "Pietro Capuzi" school: (a) external view, (b) plan of the raised ground floor, and (c) section AA [2].

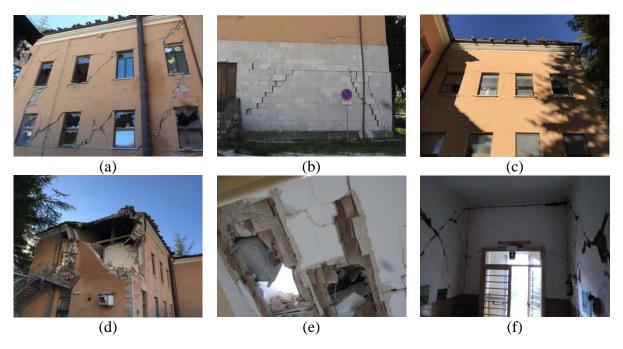
"Pietro Capuzi" school suffered severe damage due to the Amatrice-Visso-Norcia seismic sequence. A detailed description of the damage experienced by the building, updated on the date of December 8<sup>th</sup>, 2016, was reported in [6][7]. As shown in Figure 2a, the walls were affected by severe cracks at both the raised ground floor and first floor, especially in the Y direction where the damage is more severe and widespread than in the X direction. The building mainly presents diagonal shear cracks developing through the entire thickness of the

walls in both piers and spandrels. Furthermore, a shear-sliding mechanism producing an important residual deformation was activated in the northwest (NW) side of the building (Figure 2b). Flexural cracks can also be observed on the southeast (SE) side of Body B (Figure 2c). In addition to the in-plane damage, an out-of-plane mechanism occurred in the NW corner of the building, resulting in the partial collapse of the masonry walls and adjacent attic slabs (Figure 2d).

With regards to the other slabs, two local collapses occurred in the slab between the raised ground floor and first floor (Figure 2e). Furthermore, the steel slab between first floor and attic experienced an extensive collapse because of the out-of-plane mechanisms as well as cracks along the metallic profiles in the portions of slab still standing. For the connection between vertical walls and slabs, horizontal cracks were present in the external walls at the slab locations. In the interior, severe cracks were observed in correspondence of the connection between walls and slabs (Figure 2f).

Figure 2 – Damage state updated on December 8th, 2016: (a) diagonal shear cracks in piers and spandrels, (b) shear-sliding mechanism, (c) out-of-plane mechanism, (d) flexural cracks, (e) local collapse of the slab between raised ground floor and first floor, (f) cracks in correspondence of the connection between walls and slabs [6].

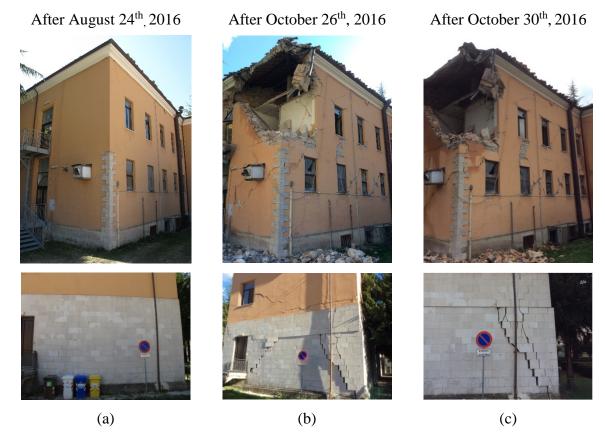
A partial reconstruction of the damage development experienced by "Pietro Capuzi" school during the Amatrice-Visso-Norcia seismic sequence was carried out thanks to the photographic documentation provided in [8]. After the seismic event of August 24<sup>th</sup>, the building exhibited an in-plane response with cracks occurring in both masonry piers and spandrels (Figure 3a). In addition to moderate cracks widespread throughout the entire building, severe cracking appeared in some piers of internal and external walls. As shown in Figure 3b, the earthquakes that occurred on October 26<sup>th</sup>, 2016 produced significant deterioration of the damage level. Not only did the severity of the in-plane damage increase significantly, but an out-of-plane mechanism also occurred. As for the in-plane response of masonry walls, it was observed than, more than in the creation of new cracks, the deterioration of the damage state mainly consisted in the enlargement of the cracks produced by the seismic event of August 24<sup>th</sup>. As shown in Figure 3c, the damage state did not change significantly after the shake of October 30<sup>th</sup> with respect to October 26<sup>th</sup>.

Figure 3 – Observed damage in "Pietro Capuzi" school after the earthquakes occurred on: (a) August 24<sup>th</sup>, 2016, (b) October 26<sup>th</sup>, 2016, and (c) October 30<sup>th</sup>, 2016 [8].

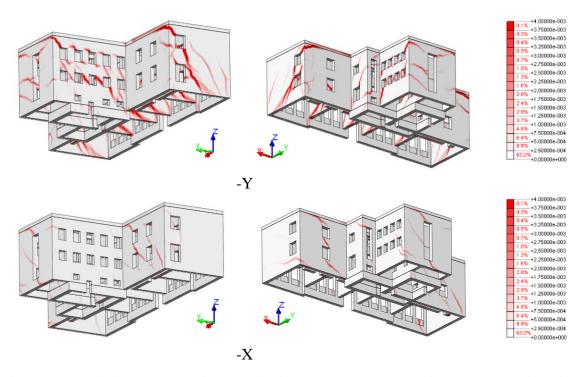
Figure 11 presents the damage pattern of masonry walls in terms of principal crack width strain for the pushover analyses in -Y and -X direction, for which the maximum values of horizontal load factor were obtained. A global failure mechanism is observed in both the directions of analysis, with masonry walls mostly affected by diagonal shear cracks. Flexural cracks are also observed, especially in the spandrels. Furthermore, it is observed that, despite the higher values of horizontal load applied in -X direction, the damage is more severe in the analysis in -Y direction, as shown by damage distribution and higher values of principal crack width strain.

Figure 11 - Principal crack width strain for pushover analyses in -Y and -X directions.
