# 2016-2017 Central Italy Earthquake: Seismic Assessment of "Pietro Capuzi" School in Visso (Marche)

# †\*Chiara Ferrero¹, Paulo B. Lourenço², and Chiara Calderini¹

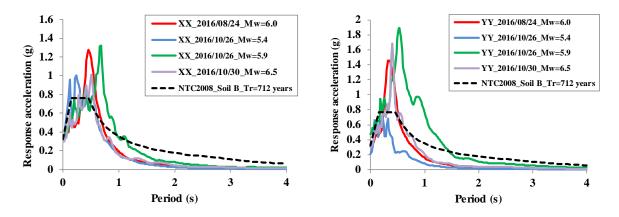
Figure 4 - Comparison between the response spectra (XX and YY component) of the seismic events of August 24<sup>th</sup>, October 26<sup>th</sup> and October 30<sup>th</sup> and the elastic spectrum of NTC2008 for soil B and return period Tr=712 years (damping 5%).

Figure 4 shows a comparison between the 5% damped acceleration response spectra of the horizontal components of motion in XX and YY directions for the four earthquakes considered, and the elastic response spectrum in accordance with the Italian Building Code (hereafter called NTC2008 [9]) for a return period of 712 years and soil of type B [3]. It is observed that the seismic events of August 24<sup>th</sup> (M<sub>w</sub> 6.0) and October 26<sup>th</sup> (M<sub>w</sub> 5.9), which caused the most severe damage to the structure, resulted in significant amplifications of the acceleration with respect to the elastic spectrum of NTC2008. Furthermore, it is important to note that the YY component of the acceleration spectrum of October 26<sup>th</sup> earthquake exceeded the code spectrum for all the significant ranges of period, thus agreeing with the severe damage suffered by the structure in this direction.

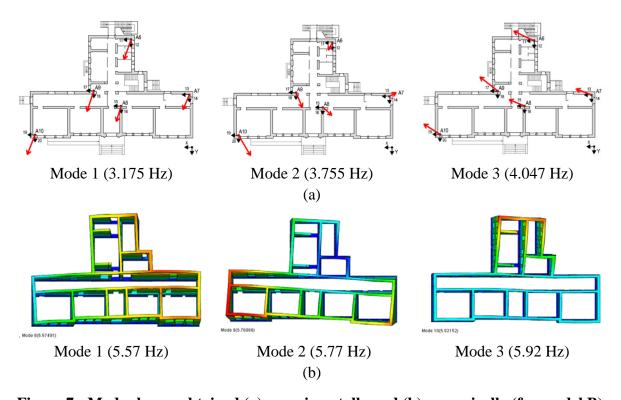
Figure 7 - Mode shapes obtained (a) experimentally and (b) numerically (for model B).

in Figure 7a for the first level of the building, was obtained in this study by drawing in scale on the plan of the building the modal displacements associated to each mode shape vector. The modes identified experimentally were global modes corresponding to: (1) a translational mode in the transversal direction of the building (mode 1 - 3.175 Hz), (2) a torsional mode (mode 2 - 3.755 Hz), and (3) a translational mode in the longitudinal direction (mode 3 - 4.047 Hz).

In order to gather more information about the modal response of the structure and visualize animations of the mode shapes, a further dynamic identification was performed in ARTeMIS Modal 5.0 software [17] by processing the signals recorded by [5] during the dynamic tests carried out in 2011. Though richer in terms of more possible frequencies, this dynamic identification whose results are reported in [18], was consistent with the one carried out by [5]. The latter was used by the authors to perform the updating of the numerical model. Hence, the model updating was focused on the three modes identified in [5], which were compared with the ones obtained numerically that presented a similar mode shape (Figure 7b). Note that only the mode shapes obtained for model B are presented in Figure 7b due to the similarity of results obtained for the three models.

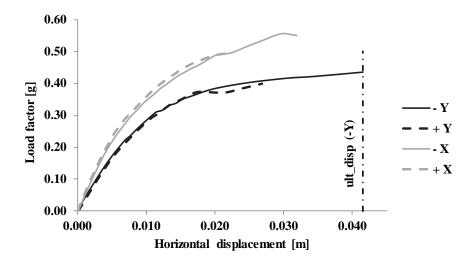
Figure 10 - Capacity curves obtained from the analyses performed in +X, -X, +Y and -Y directions.

Figure 10 shows the capacity curves obtained for the pushover analyses performed in +X, -X, +Y and -Y. As for -Y direction, it is important to note that the curve exhibited a long, almost flat, plateau, consistent with a shear or rocking failure mode of masonry elements, without material crushing or geometrical non-linear effects. This made the last point of the curve physically less meaningful, but only related to convergence issues. For this reason, the ultimate capacity of the structure was estimated by taking into consideration the value of ultimate displacement indicated by the Italian Circolare [14] for the verification with respect to ultimate (life safety) limit state for existing masonry buildings. Consequently, the capacity curve presented in Figure 10 was interrupted when the values of ultimate displacement was overcome. Note that the same verification was performed for the analyses carried out in +Y, -X and -X direction, but in these cases the ultimate displacement was not exceeded.

As shown in Figure 10, the building exhibits a higher stiffness and lateral load-carrying capacity in X direction than in Y direction. The maximum values of lateral load factor obtained from the analyses in -X and -Y are, indeed, equal to 0.55 g and 0.44g, respectively. It is observed that the structure is characterized by a lower capacity in +Y and +X directions with respect to -Y and -X directions, respectively. However, this can be attributed to the fact that the curves in +Y and +X directions were plotted for smaller ultimate displacements, as the curves almost coincide in the positive and negative directions.
