Analysis of Steel Moment Frames subjected to Vehicle Impact

Structures are often subject to vehicle collision which can be accidental or intentional as in the case of a terrorist attack. This study investigates the performance of a 2D and a 3D steel moment frame subjected to vehicle collision at a first story column using LS-DYNA. The finite element models of vehicles provided by the National Crash Analysis Center (NCAC) are used for numerical analysis. Nonlinear dynamic time history analysis of the 2D model structure is carried out based on the arbitrary column removal scenario and the vertical displacement of the damaged structure is compared with that obtained from collision analysis. The analysis results show that the model structure remain stable when the speed of the car is 40km/h. However at the speed of 80 and 120 km/h both the 2D and 3D structures collapse by progressive collapse. The vertical displacement of the damaged joint obtained from collision analysis is significantly larger than the displacement computed based on the arbitrary column removal scenario.

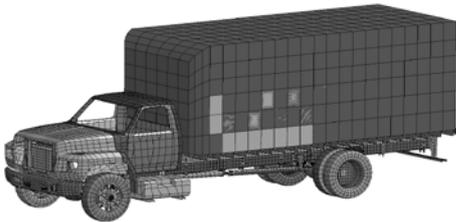
Figure 1. F800 FEM truck model

The automobile used in the impact analysis is the eight-ton single unit truck shown in Fig. 1 provided by the NCAC (National Crash Analysis Center), and the detailed finite element modeling information is shown in Table 1. The vehicle is built on a main longitudinal rail structure that acts as its backbone. The material of the rails is specified in the Service Manual as the High Strength Low Alloy (HSLA) steel of yield point 350 MPa. The yield stress of the steel forming the surface of the truck is 155MPa, and that of the other components is 270 MPa. The mass density and elastic modulus of steel used in the model are 7.85 kN/m²/g and 205,000MPa, respectively. It was assumed that 2.8ton of mass is loaded on the truck, which leads to total mass of 8.035 ton. The material data available from the Auto/Steel Partnership [4] and American Iron and Steel Institute [5] was used to enhance the existing material model.

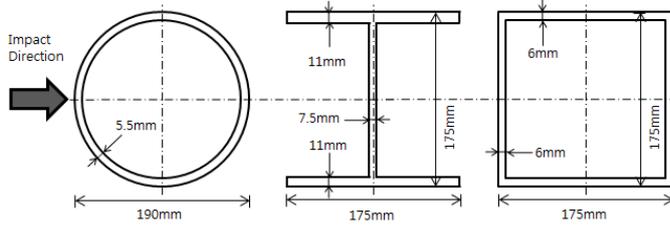
Figure 2. Cross-section of steel column

Impact analysis is carried out on a single steel column with fixed boundary conditions at both ends. The analysis results of columns with a hollow circular (C-column), a square (S-column), and a H section shown in Fig. 2 are compared. The columns have the same length and are designed for the same loading condition. The steel columns are modeled with solid elements, and the contact condition between the column and the automobile is defined by *CONTACT_AUTOMATIC_SURFACE_TO_SURFACE function in LS-Dyna. The friction coefficient between the ground and the wheels is assumed to be 0.01. The *CONTACT_INTERIOR condition is used to prevent the occurrence of negative volume due to large deformation of the automobile. Fig. 3 shows the stress-strain relationship of the A572 steel of which the columns are made.

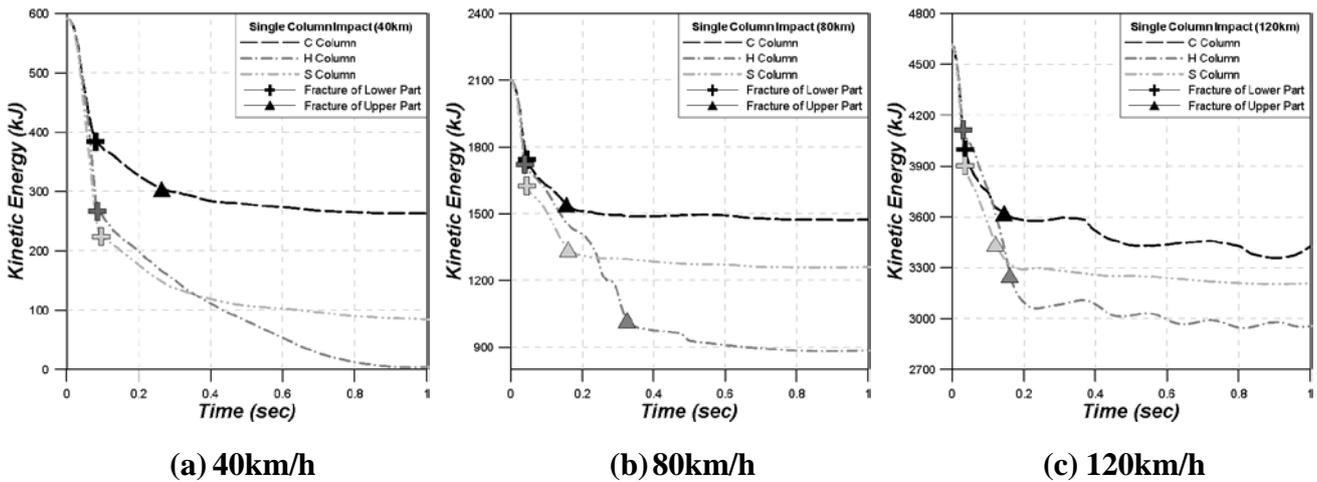
Figure 4. Variation of kinetic energy

The impact simulation is carried out with three different car speeds: 40, 80, and 120 km/h. Fig. 4 depicts the variation of kinetic energy generated during the collision. The analysis results show that in every case the rate of decrease in kinetic energy (i.e. the rate of decrease in car speed after impact) is smallest in the circular column. The kinetic energy decreases most rapidly in the H-shaped column which has the largest cross sectional area. When the speed is 40km/h the kinetic energy associated with the collision to the H-shaped column becomes zero at 1.0 second after the impact, which implies that the car stopped completely due to the collision. On the other hand the existence of kinetic energy at 1.0 second in other columns implies that the columns are completely destroyed by the car crash and the car is still moving.

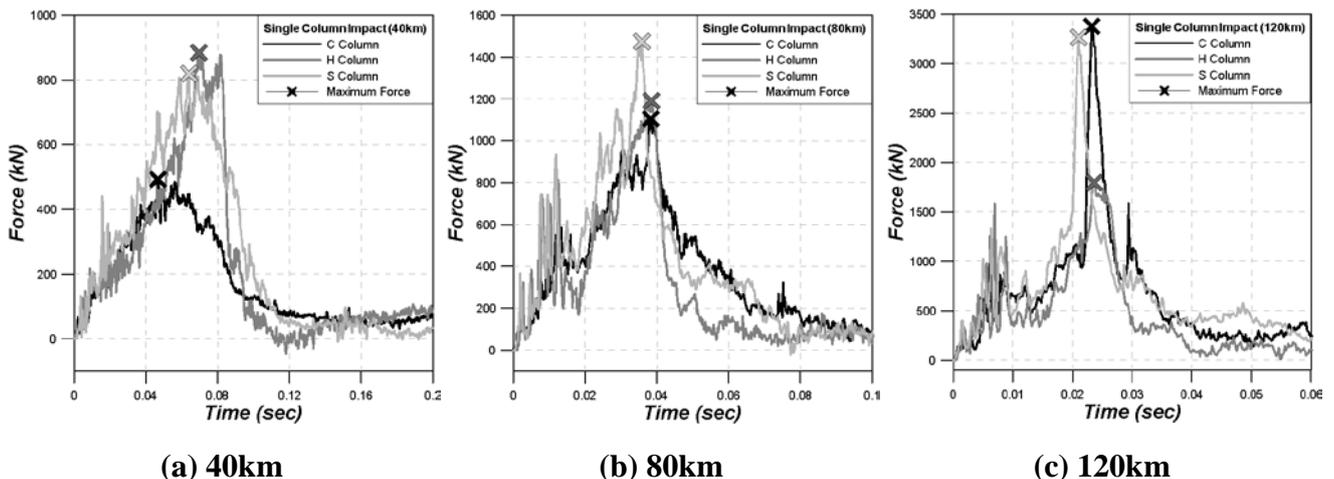
Figure 5. Variation of impact force for different car speeds

Figure 5 shows the variation of impact force for three different car speeds and the maximum values are summarized in Table 2. The impact force is smallest in the circular column when the car speed is lowest. However in the highest speed the impact force of the circular column turns out to be highest. The opposite is observed in the H-shaped column.

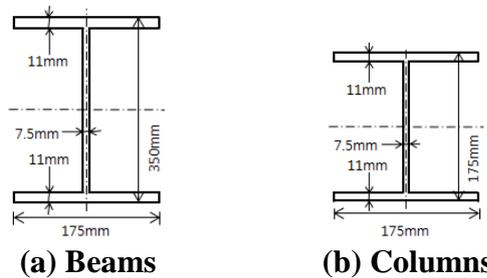
Figure 7. Cross-section of elements

The analysis model structure is a three-story three-bay moment resisting frame with 5m span length and 4m story height as shown in Fig. 6. The beams and columns are designed with steel H-shaped members with A36 and A572 steel, respectively. The cross-sectional information is shown in Fig. 7. The structure is designed with dead and live loads of 5 and 3 kN/m², respectively. The structure is modeled in the LS_Dyna with 416,224 solid elements. The columns are modeled to be continuous throughout the stories and the beams are welded to columns. Two horizontal continuity plates are located between column flanges across the connections at the level of beam flanges. The limit strain or the elongation at break is assumed to be 0.2, 0.18, and 0.1 for beams, columns, and connections, respectively, in the analysis. Table 3 shows the material properties of the model structure, and the stress-strain curves for beams and columns are depicted in Fig. 3. Fig. 8 depicts the finite element mesh of a typical beam-column joint.

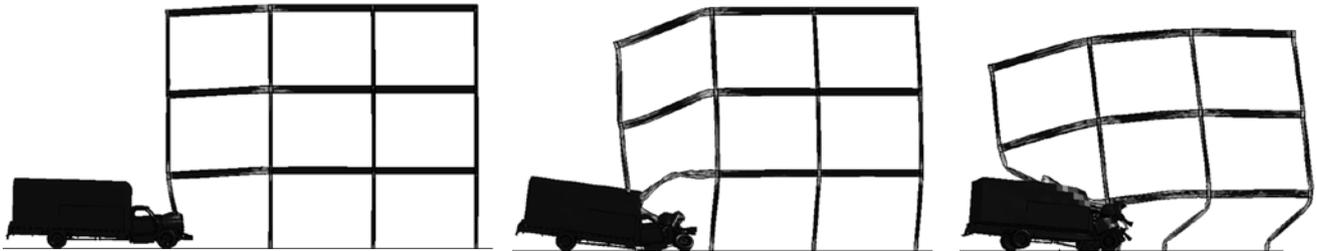
(a) 40km/h (b) 80km/h (c) 120km/h
Figure 9. 2D frame impact simulation results (t=1 sec.)

Collision analysis is carried out with one of the internal frame separated from the 3D model structure shown in Fig. 6. Fig. 9 shows the deformed shapes of the structure 1.0 second after

collision. It is observed that when the speed of the truck is 40km/h only the exterior column is severely damaged due to the collision with the truck but is not separated from the joint. When the car speed is increased to 80km/h the bottom of the collided column is completely separated from the joint and the left-hand-side bay collapses due to progressive collapse. At the speed of 120km/h the truck goes through the exterior column and collides with the adjacent interior column. The other first story columns are also severely damaged due to large lateral displacement.

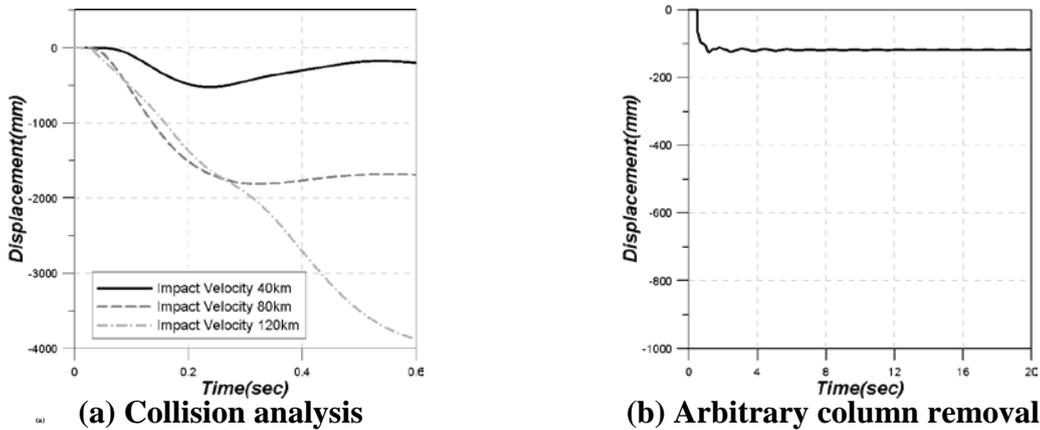
(a) Collision analysis (b) Arbitrary column removal
Figure 10. Vertical displacement obtained from collision analysis and arbitrary column removal method

Figure 10(a) shows the vertical displacement of the first story exterior beam-column joint obtained from the collision analysis with three different car speed. It can be observed that at the speeds of 40 and 80km/h the collision results in significant vertical displacements but the vertical displacements remain stable. However at the speed of 120km/h the vertical displacement decreases almost unbounded, which implies collapse of the structure. Fig. 10(b) depicts the vertical displacement at the same point obtained by arbitrary sudden removal of the first story column. Compared with the results of the collision analysis, the vertical displacement obtained by the arbitrary removal of the column is significantly smaller. This is due to the fact that after collision the catenary force caused by the large bending deformation of the column pulls the joint down, which cannot be considered in the arbitrary column removal scenario.

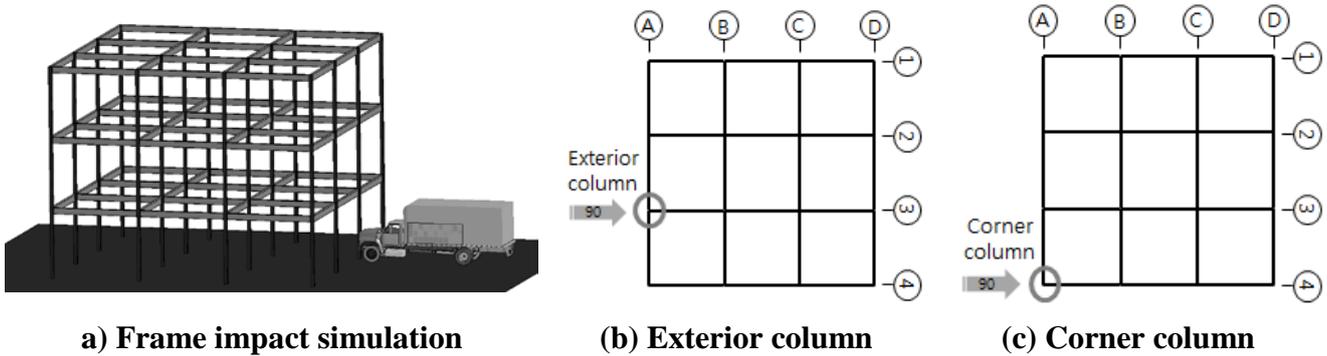
Figure 11. Steel frame impact simulation and impact direction on plane condition

Figure 11 shows the collision of the truck to the exterior and corner column of the 3D analysis model, and the analysis results for car speed of 120km/h are shown in Fig. 12. It is observed that the bottom of the exterior column is completely separated from the joint at 0.03 second after the impact. After passing through the exterior column the car continues to move until colliding with the adjacent interior column at t=0.19 second. As in the 2D model, the car collision results in progressive collapse. The vertical displacement of the upper joint of the impacted column is shown in Fig. 12(a), where it can be observed that the vertical deflection oscillate after the first impact to the exterior column and keeps decreasing after the second impact to the interior column. Fig. 12(b) depicts the deformed second story floor plan with respect to the original configuration. It can be observed that due to the series of collisions the second story is displaced laterally in significant amount and many floor beams suffers moderate to severe damage based on the failure criteria of ASCE (1000) shown in Table 4. The deformed configuration of the structure at the final stage of analysis is shown in Fig. 12(c), where it can be observed that the first story columns of the two right-hand-side frames are severely damaged and the structure is significantly tilted. Fig. 13 depicts the collision analysis results of the structure subjected to the car impact to the corner column. The vertical deflections at the joints increase monotonically after the first impact as shown in Fig. 13(a), which implies that the structure collapses progressively due to the collision to the corner column. This can be confirmed by the deformed configuration of the structure depicted in Fig. 13(b), which shows that all the first story exterior columns in the right-hand-side frame are severely damaged and the exterior frame is collapsed. Compared with the results of collision to the exterior column shown in Fig. 12, the car collision to the corner column results in more severe damage to the impacted part of the structure.

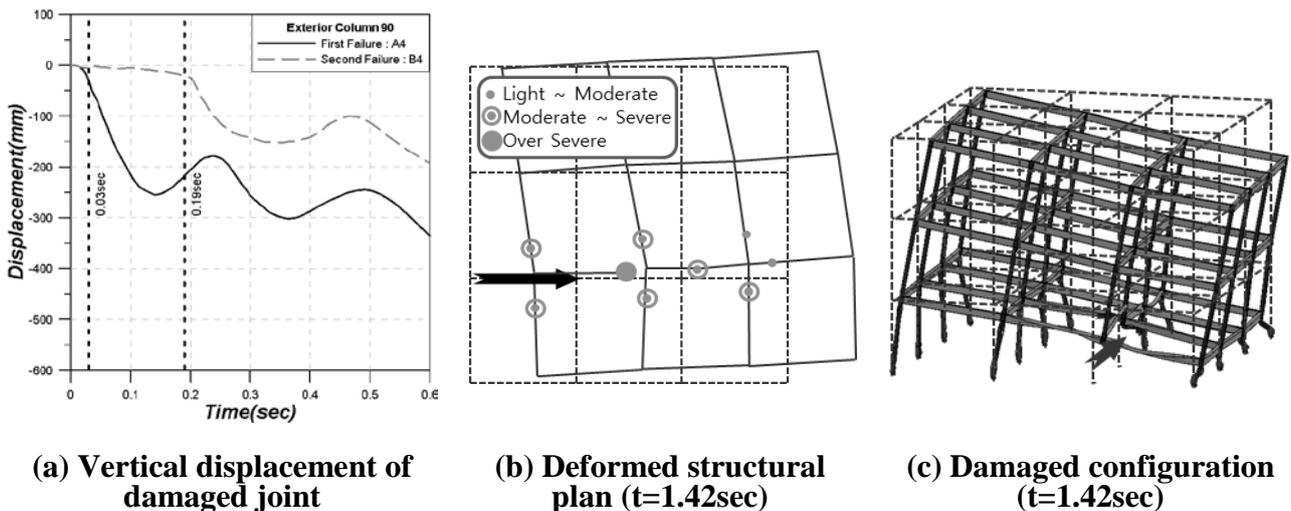
Figure 12. Analysis results for exterior column collision

(a) Vertical displacement of damaged joint (b) Deformed structural plan (t=1.42sec) (c) Damaged configuration (t=1.42sec)

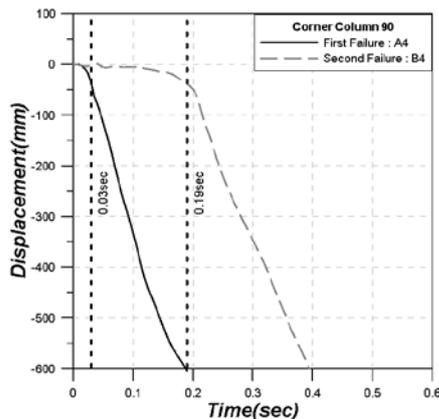
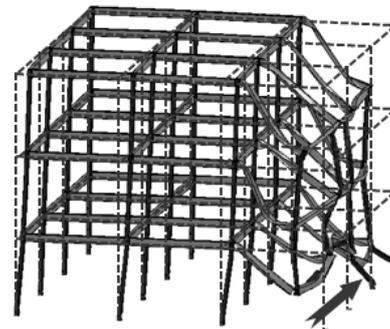
(a) Vertical displacement of damaged joint (b) Deformed configuration of the structure
Figure 13. Analysis results for corner column collision
